# PAVILION V

HISTORIC STRUCTURE REPORT

MESICK · COHEN · WAITE  
ARCHITECTS  
1994

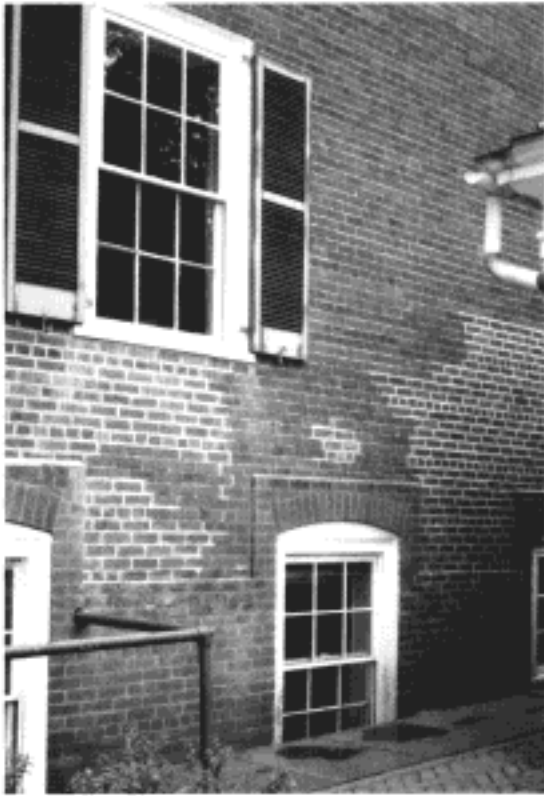
*South elevation with improper pointing*

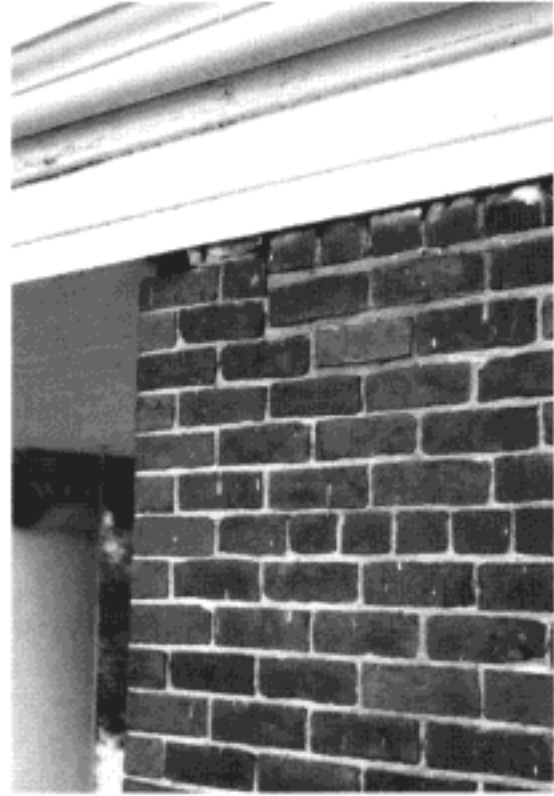
*Improper pointing and open mortar joints at the east end of the north elevation*

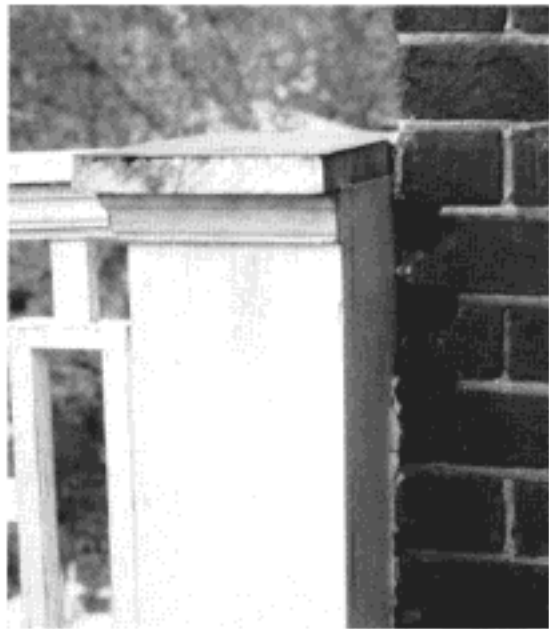
*Broken brick at the west end of the south roof terrace*

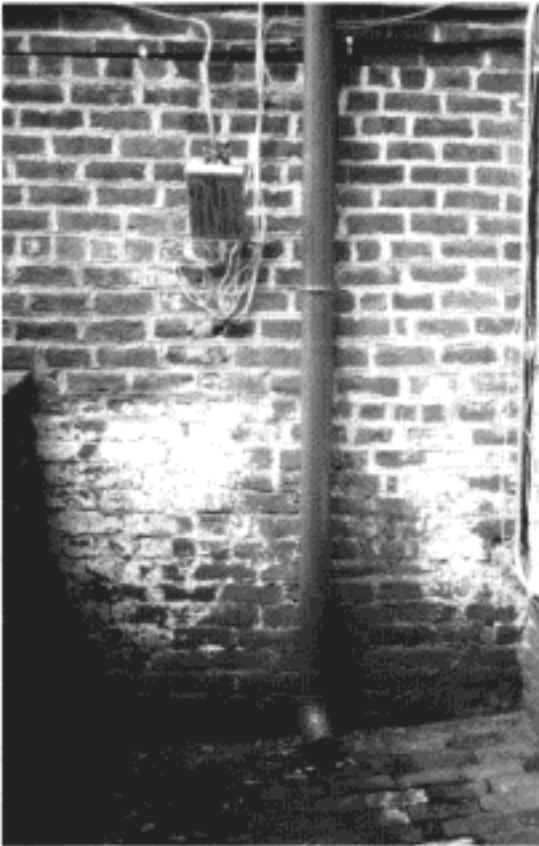
*Areaway at the northwest corner of the pavilion with surface-mounted wiring, improper pointing, and open joints in the paving*

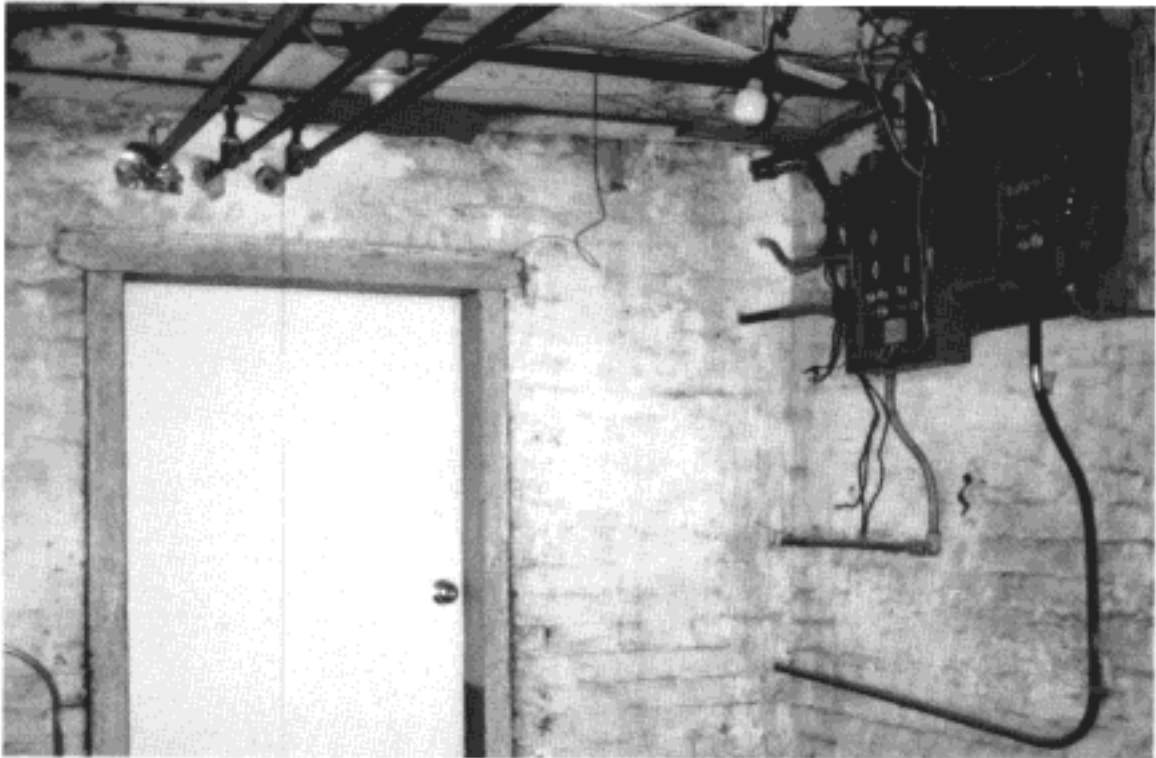
*Ad hoc installation of wiring and plumbing beneath the connecting hyphen*

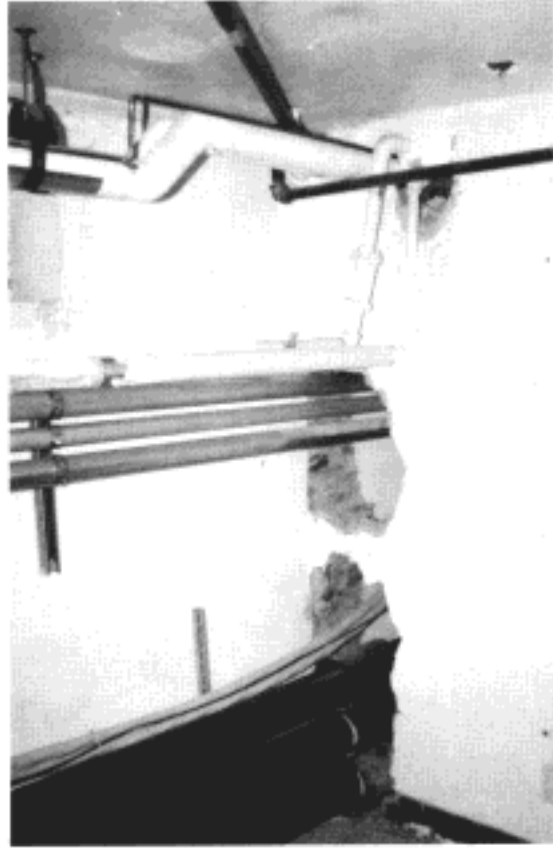
*Intervention in original building fabric for the installation of utilities*

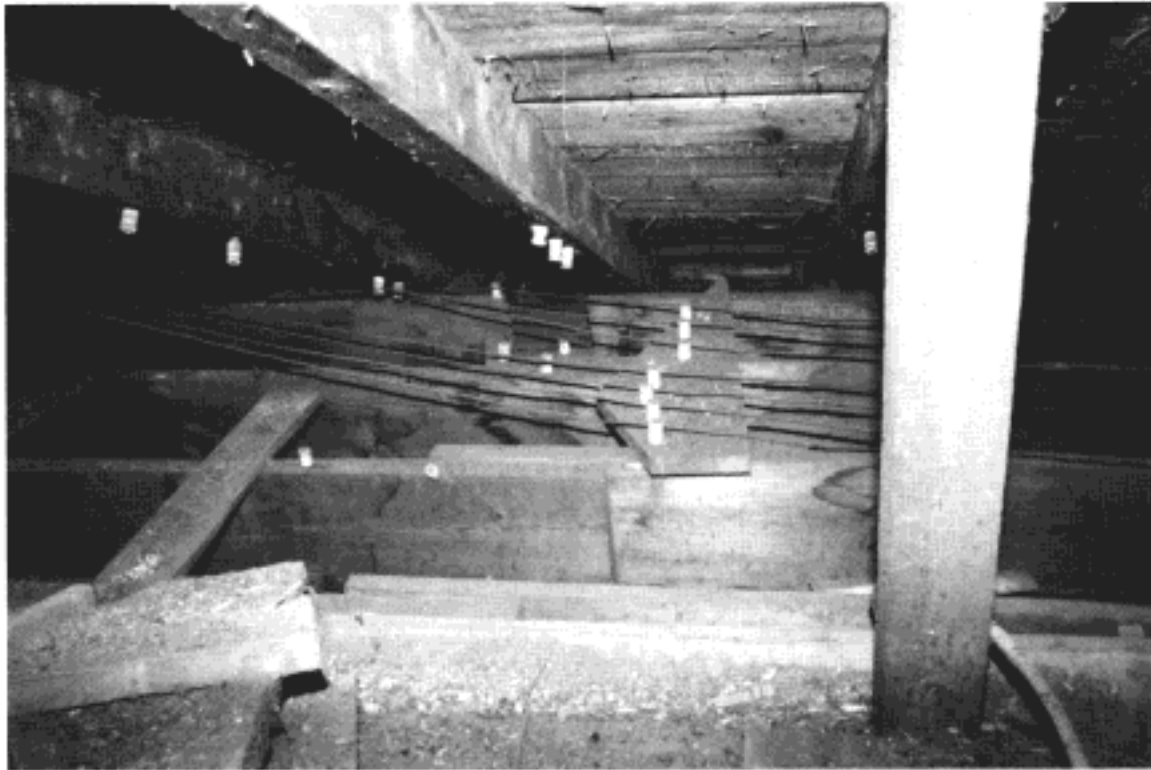
*Knob-and-tube wiring in the attic of the original building*

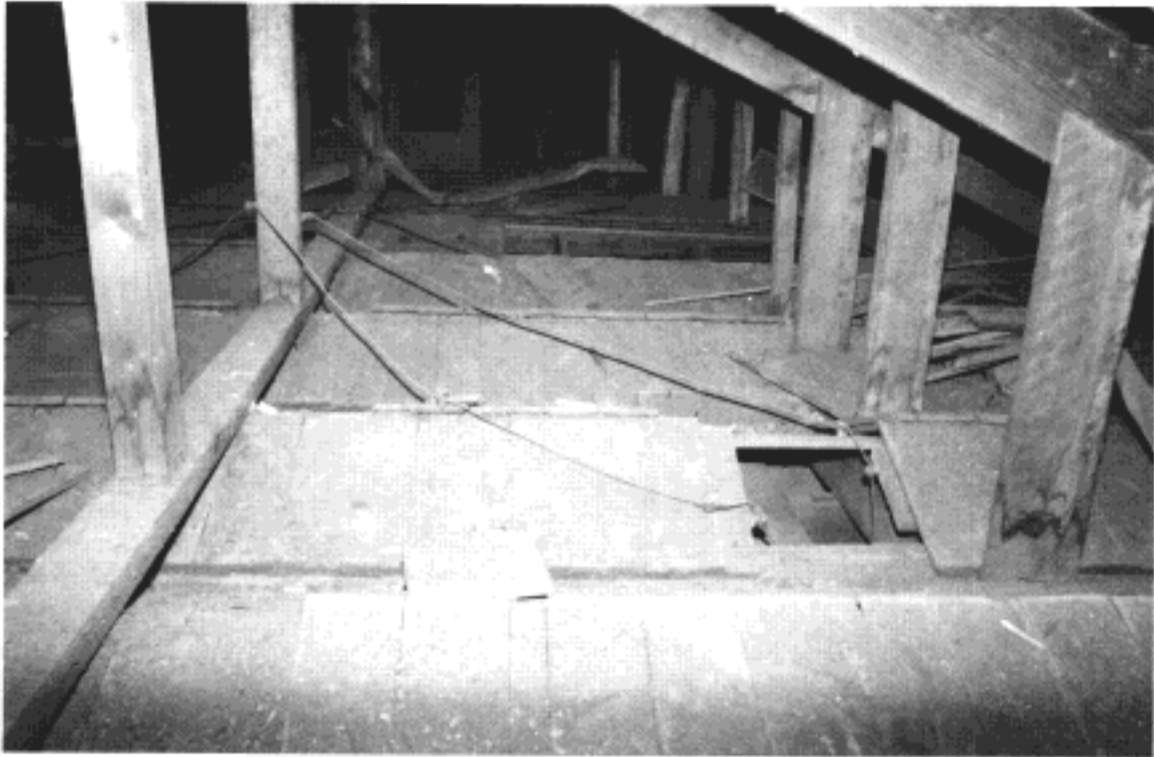
*Accumulated debris and fine, silt-like dust cover the encapsulated ridge-and-furrow roof*

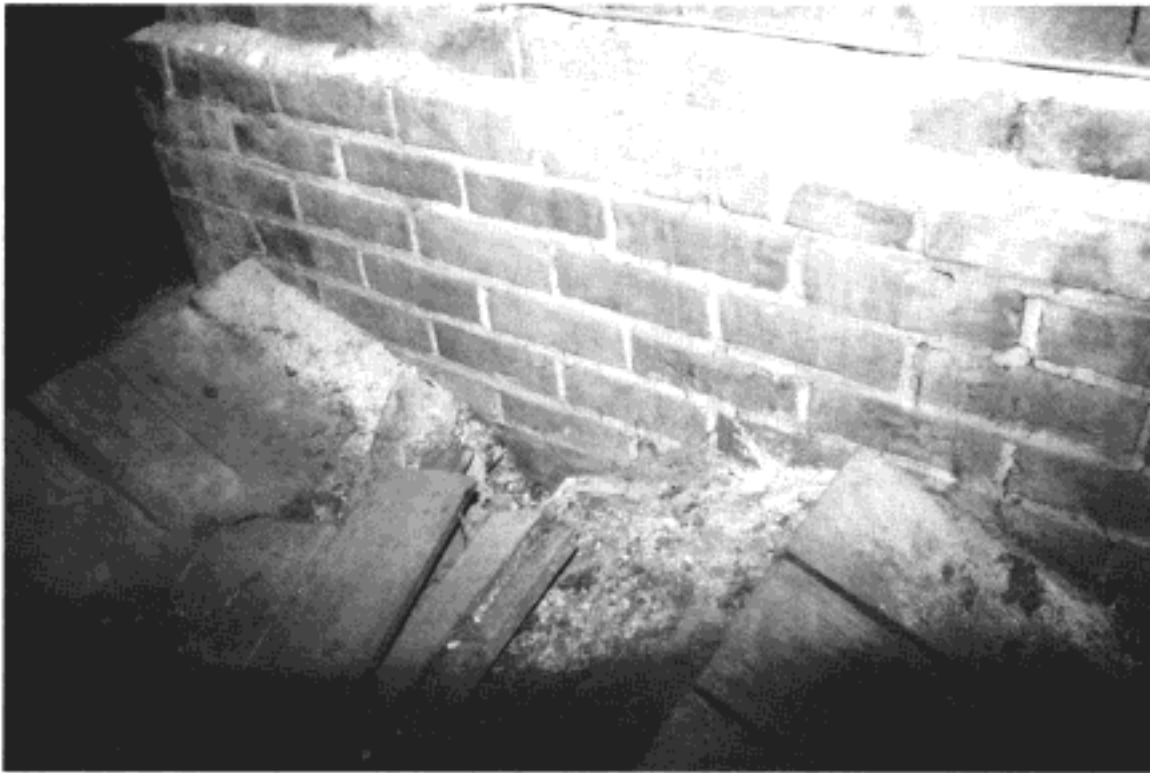
*Deteriorated mortar at the base of the original chimney*
