# PAVILION V

HISTORIC STRUCTURE REPORT

MESICK · COHEN · WAITE  
ARCHITECTS  
1994

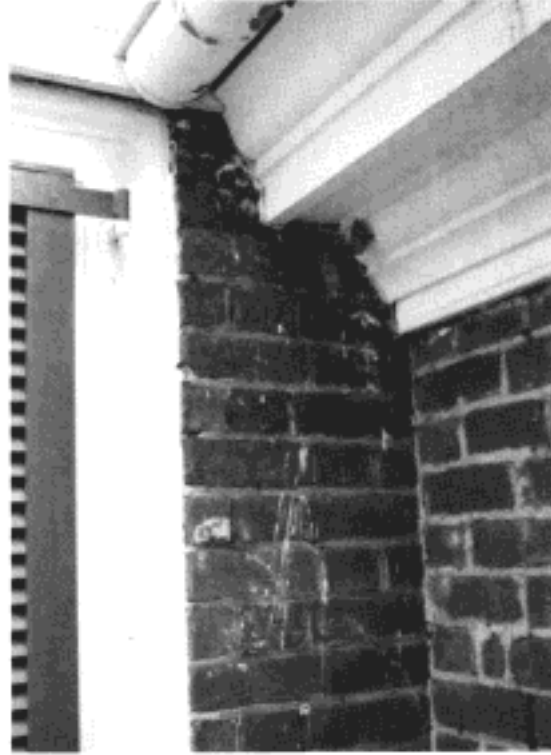
*Ghost of original hyphen entablature appears  
on south face of pavilion*

Paint layering on the hyphen entablatures (about 13 layers) indicates that these elements date to circa 1850. The entablatures were moved upward when the hyphen was modified and enlarged circa 1903/1929.

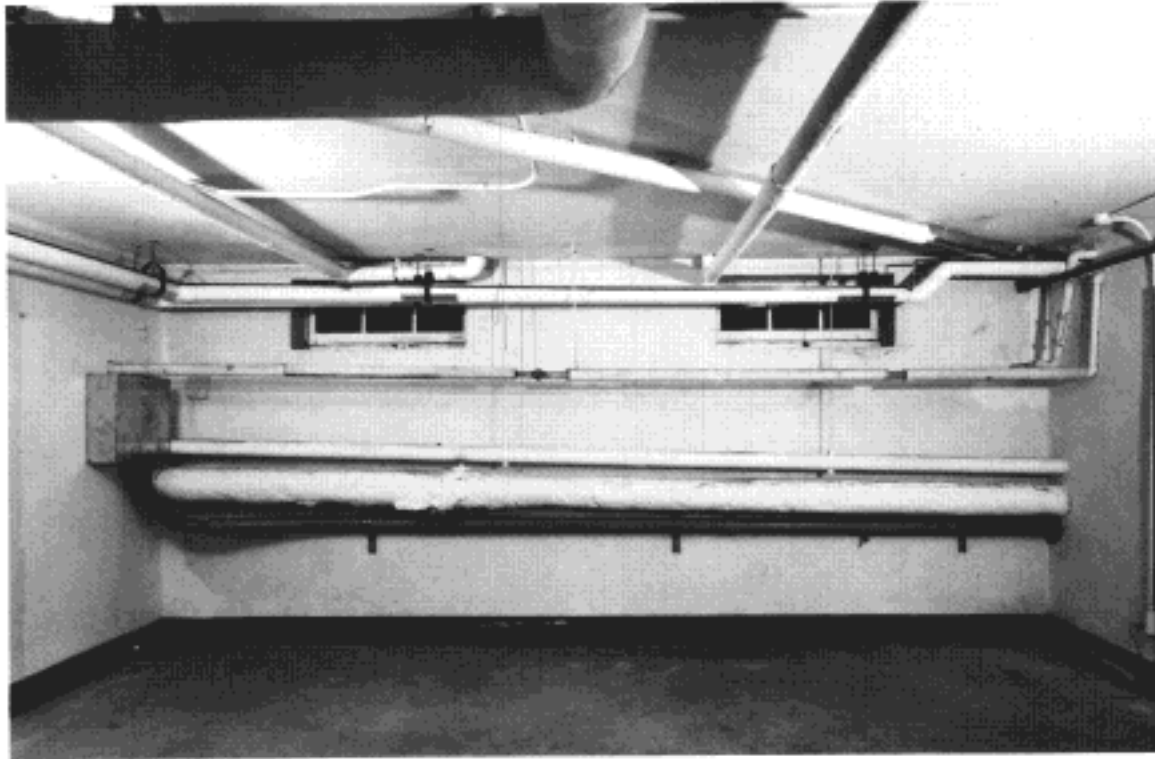
*Room B03 Storage*

Recent work (1992) involving the installation of piping and conduits has considerably damaged the original plaster and masonry of the north and south walls.

*Walls:* Original plaster on brick masonry, with areas of more recent plaster repair.

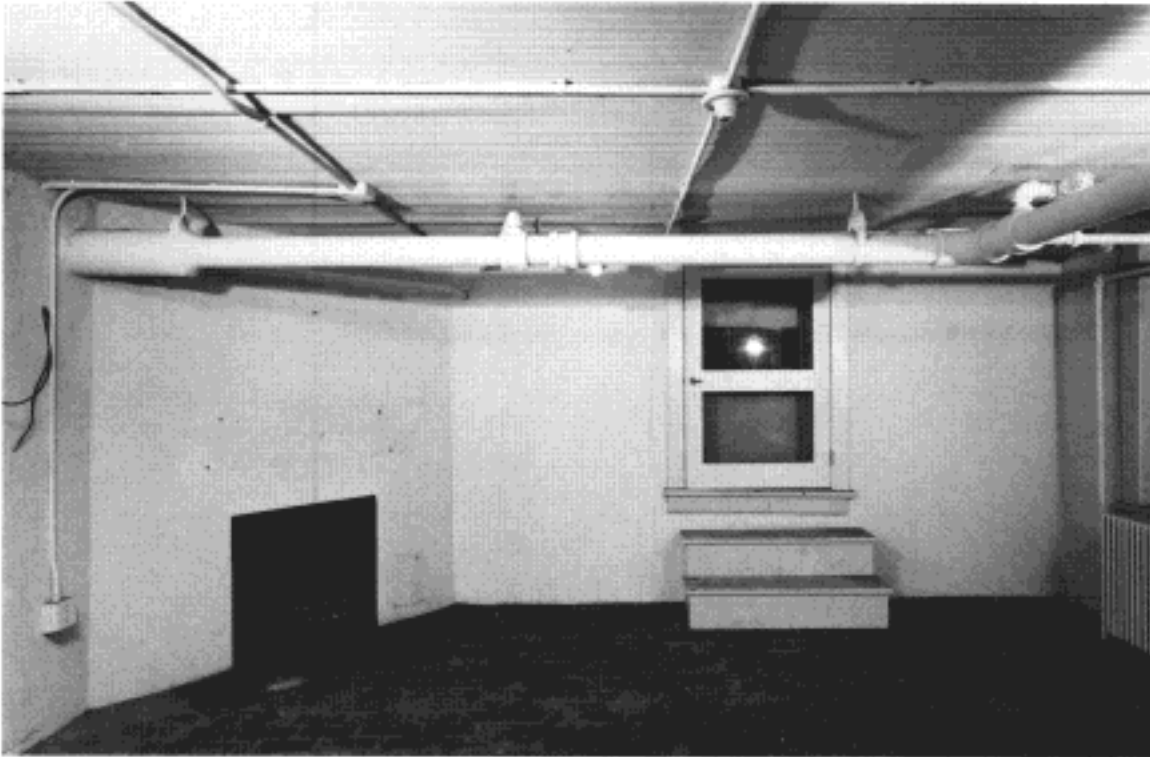
*Room B08 Storage*

*Floor:* Twentieth-century concrete. Remnants of 12" square vinyl tiles (removed in 1992) remain on the floor. This floor replaces the original brick surface, which can still be seen in the hall (Room B07).

*Ceiling:* Painted plaster on expanded metal lath 6' 7" above floor. This recent finish replaced the plaster on sawn wood lath that had covered the original whitewashed exposed framing.

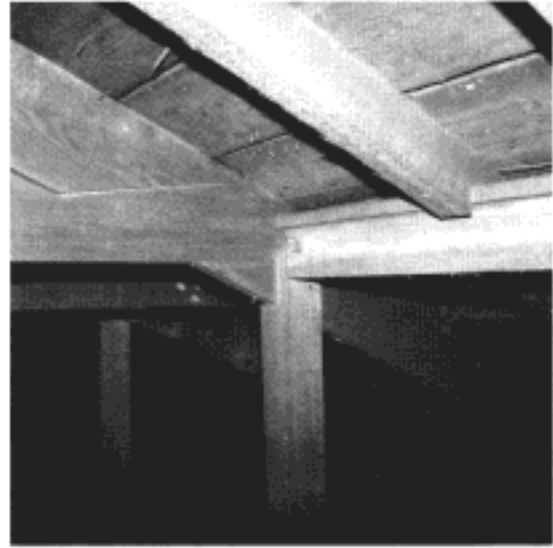
*Original wood gutter reused as purlin in hipped roof*

Pieces of the original wood gutter system were incorporated in the construction of knee-wall framing that supports the rafters of the replacement roof.

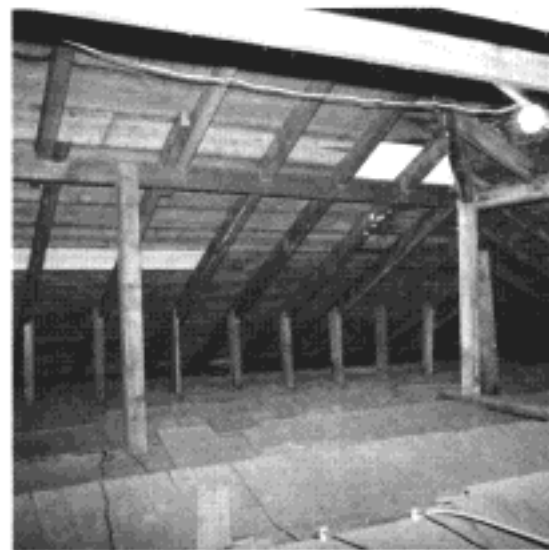
*Jefferson's ridge-and-furrow roof, encapsulated beneath 1837 hipped roof*

The roof structure above the original building envelope was altered in 1837, when a hipped roof was constructed, encapsulating Thomas Jefferson's ridge-and-furrow roof design. Jefferson's intent had been to create the appearance of a flat roof, as viewed from the ground. Similar roof configurations were designed for Pavilion VIII and for the ranges of student rooms linking the hotels and pavilions. Jefferson also had ridge-and-furrow roofs on Monticello and Poplar Forest. In each instance Jefferson's design proved inadequate. By the mid-nineteenth century the flat roofs on the university buildings had been replaced with more traditional gabled and hipped roofs.
